**Subject: Interior Surface Sampling, Exterior Window Pane and Sill Sampling,  
Pre and Post-Cleaning Sampling Results - Units 10-200 & 11-200**

**Site Address:** Rainier Commons  
3100 Airport Way S  
Seattle WA

**NVL Project #:** 2012-494

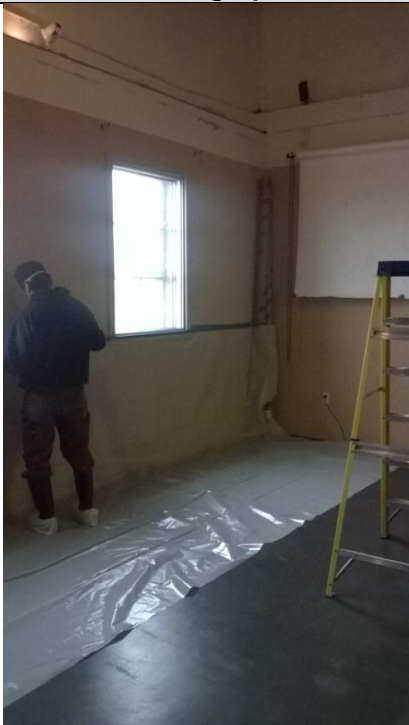
#	Photograph	Notes
1

<b>Unit 11-200</b>  Preparation for removal of double paned soundproofing window necessary to access and collect sample of bulk dust trapped on exterior of double paned window, between double paned soundproofing window and original exterior single pane.
2

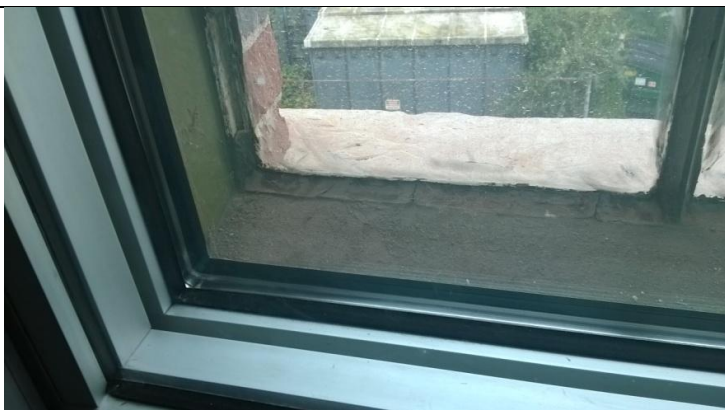
<b>Unit 11-200</b>  South Window. Pre-sample conditions prior to double paned soundproofing window being removed. Bulk dust that was collected is seen on the sill exterior to the soundproofing wall.

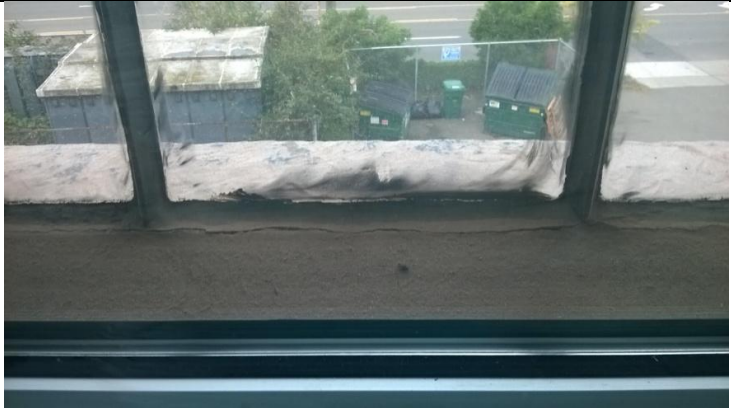
3

<p><b>Unit 11-200 PRE-Cleaning</b></p> <p>North Window. Pre-sample conditions prior to double paned soundproofing window being removed. Removal of interior double pane window was necessary in order to access exterior sill area between double paned window and original single paned window.</p>
4

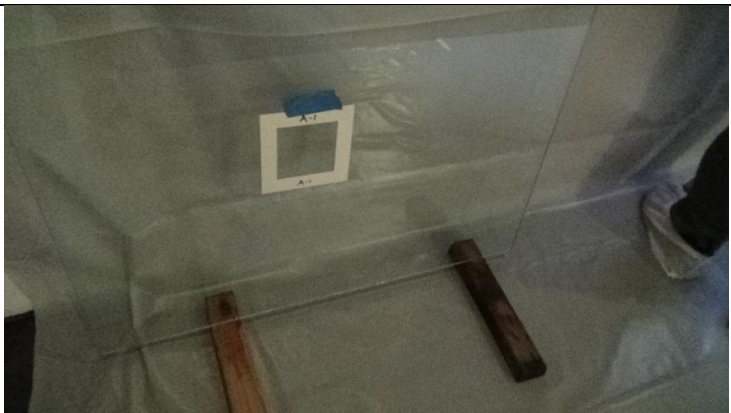
<p><b>Unit 11-200 PRE-Cleaning SURFACE "WIPE" – PCBs</b></p> <p>Inside pane surface of "sound proofing glass" <b>Sample A-1</b></p> <p><b>Testing Result Summary: No PCBs detected.</b></p>
5

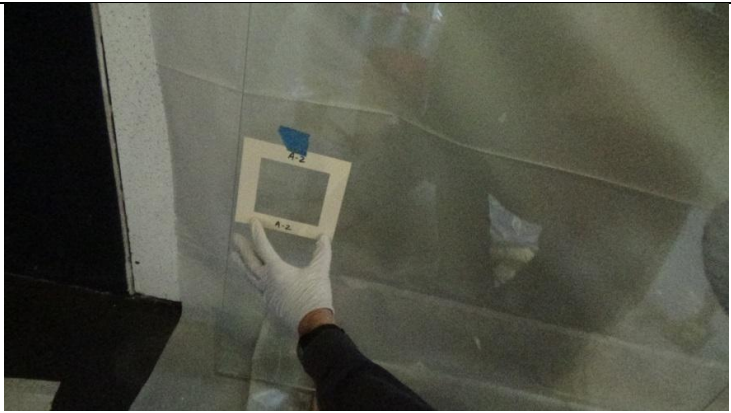
<p><b>Unit 11-200 POST-Cleaning SURFACE "WIPE" - PCBs</b></p> <p>Inside pane surface of "sound proofing glass" <b>Sample A-2</b></p> <p><b>Testing Result Summary: No PCBs detected</b></p>

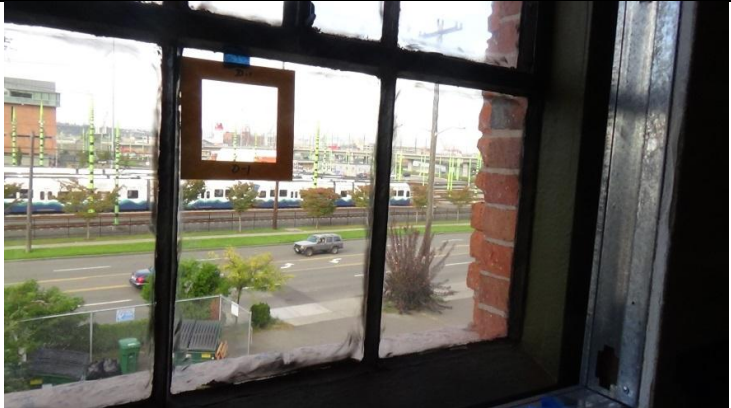
6

<p><b>Unit 11-200</b>  <b>PRE-Cleaning</b>  <b>SURFACE "WIPE" -</b>  <b>PCBs</b>          Inside pane surface of          "structural glass" or          original exterior single          pane window  <b>Sample D-1</b></p> <p><b>Testing Result</b>  <b>Summary:</b>  <b>No PCBs detected.</b></p> <p>Photo shows 100 cm<sup>2</sup>          template on glass surface.</p>
7

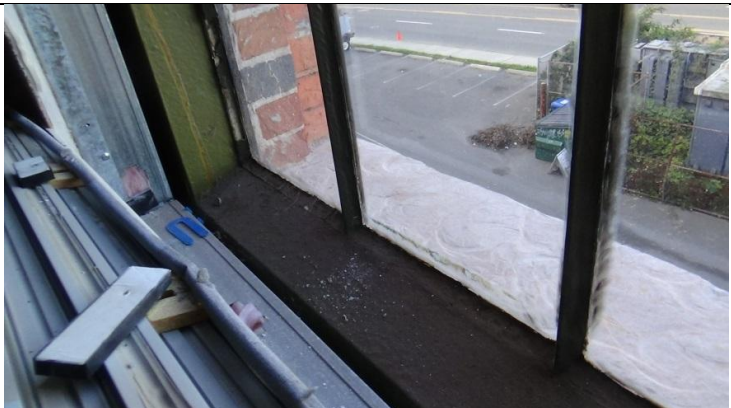
<p><b>Unit 11-200</b>  <b>PRE-Cleaning</b>  <b>Settled Dust</b>          South Window - window          sill exterior to double          paned sound proofing          window, between double          paned and single paned          window  <b>Sample 102714-BULK-1</b></p> <p><b>Testing Result</b>  <b>Summary:</b>  <b>PCBs detected</b>          3,100 PPM</p> <p><b>Metals detected</b>          Chromium, Copper and          Zinc. No Nickel detected.</p>
8

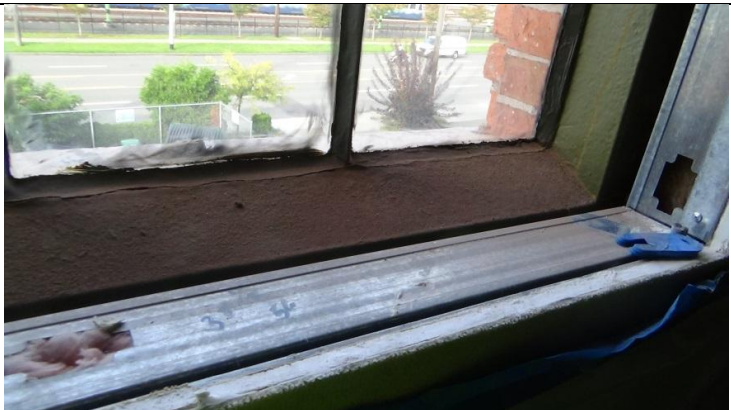
<p><b>Unit 11-200</b>  <b>PRE-Cleaning</b>  <b>Settled Dust</b>          North Window - window          sill exterior to double          paned sound proofing          window, between double          paned and single paned          window  <b>Sample 102714-BULK-2</b></p> <p><b>Testing Result</b>  <b>Summary:</b>  <b>PCBs detected</b>          11,800 PPM</p>

<b>Metals detected</b> Chromium, Copper and Zinc. No Nickel detected.
9

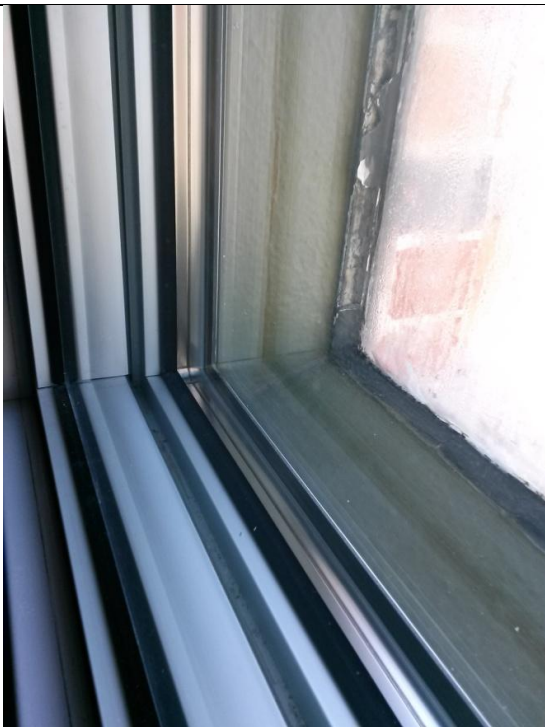
<b>Unit 11-200</b> <b>POST-Cleaning</b>  View showing clean interstitial south window sill after double paned soundproofing glass re-installed.

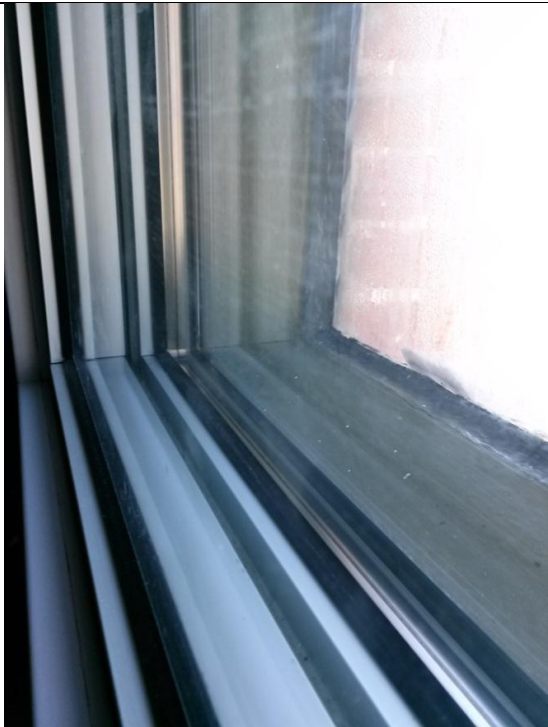
10

<p><b>Unit 11-200 POST-Cleaning</b></p> <p>View showing clean interstitial north window sill after double paned soundproofing glass re-installed.</p>
11

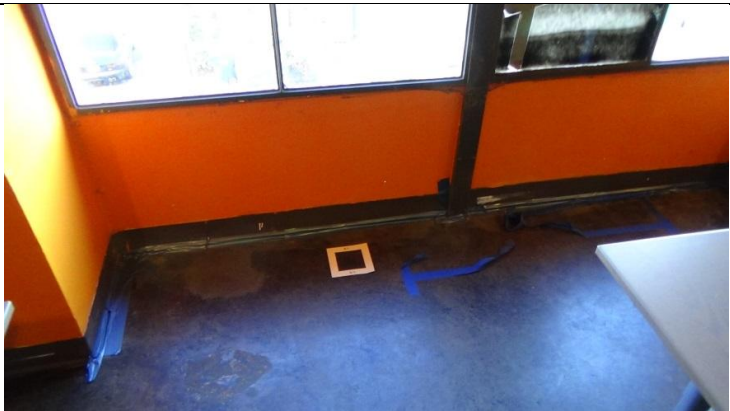
<p><b>Unit 10-200 PRE-Cleaning SURFACE “WIPE” – PCBs</b></p> <p>Floor in front of windows <b>Sample E-1</b></p> <p><b>Testing Result Summary: PCBs detected 27.7 µg/100 cm<sup>2</sup></b></p> <p>It was reported that previous testing for PCBs by the tenant was performed in the area to the right, so care was taken not to collect samples in that area to control for any cleaning effect the prior sampling may have provided.</p>
